# Case Histories of Earth Pressure-Induced Cracking of Locks

by Robert M. Ebeling, Robert C. Patev, Reed L. Mosher

Final report

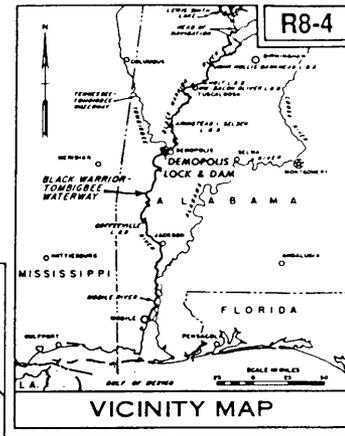
Figure 22. Location, layout, and typical cross sections for Demopolis Lock and Dam (after USACE 1992)
